# MsSRv5M™ Sixth-Generation Magnetostrictive Sensor Instrumentation System Specifications

# High-Resolution Defect Imaging in Industrial Components

## Using Guided Wave Magnetostrictive Transducer Arrays

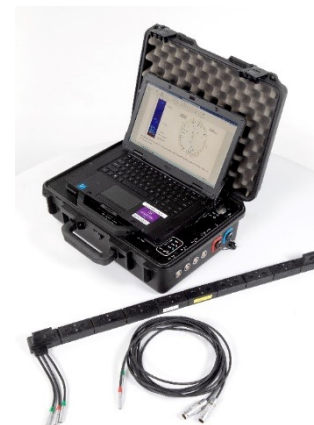
MsSRv5M instrument and -segment array on MsT 8x8 probe

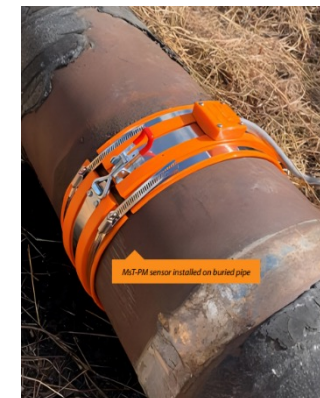
MsT probe for permanent monitoring installed on a pipe

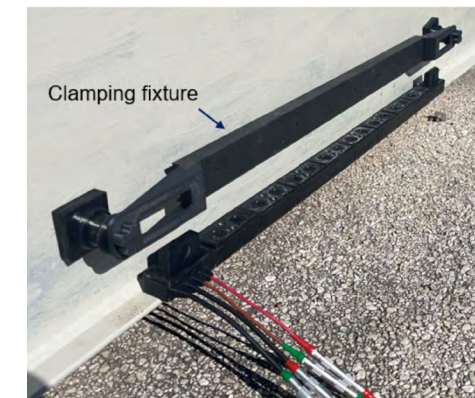
MsT probe with tank bottom extension
