SOUTHWEST RESEARCH INSTITUTE

Turbomachinery Material Analysis and Testing

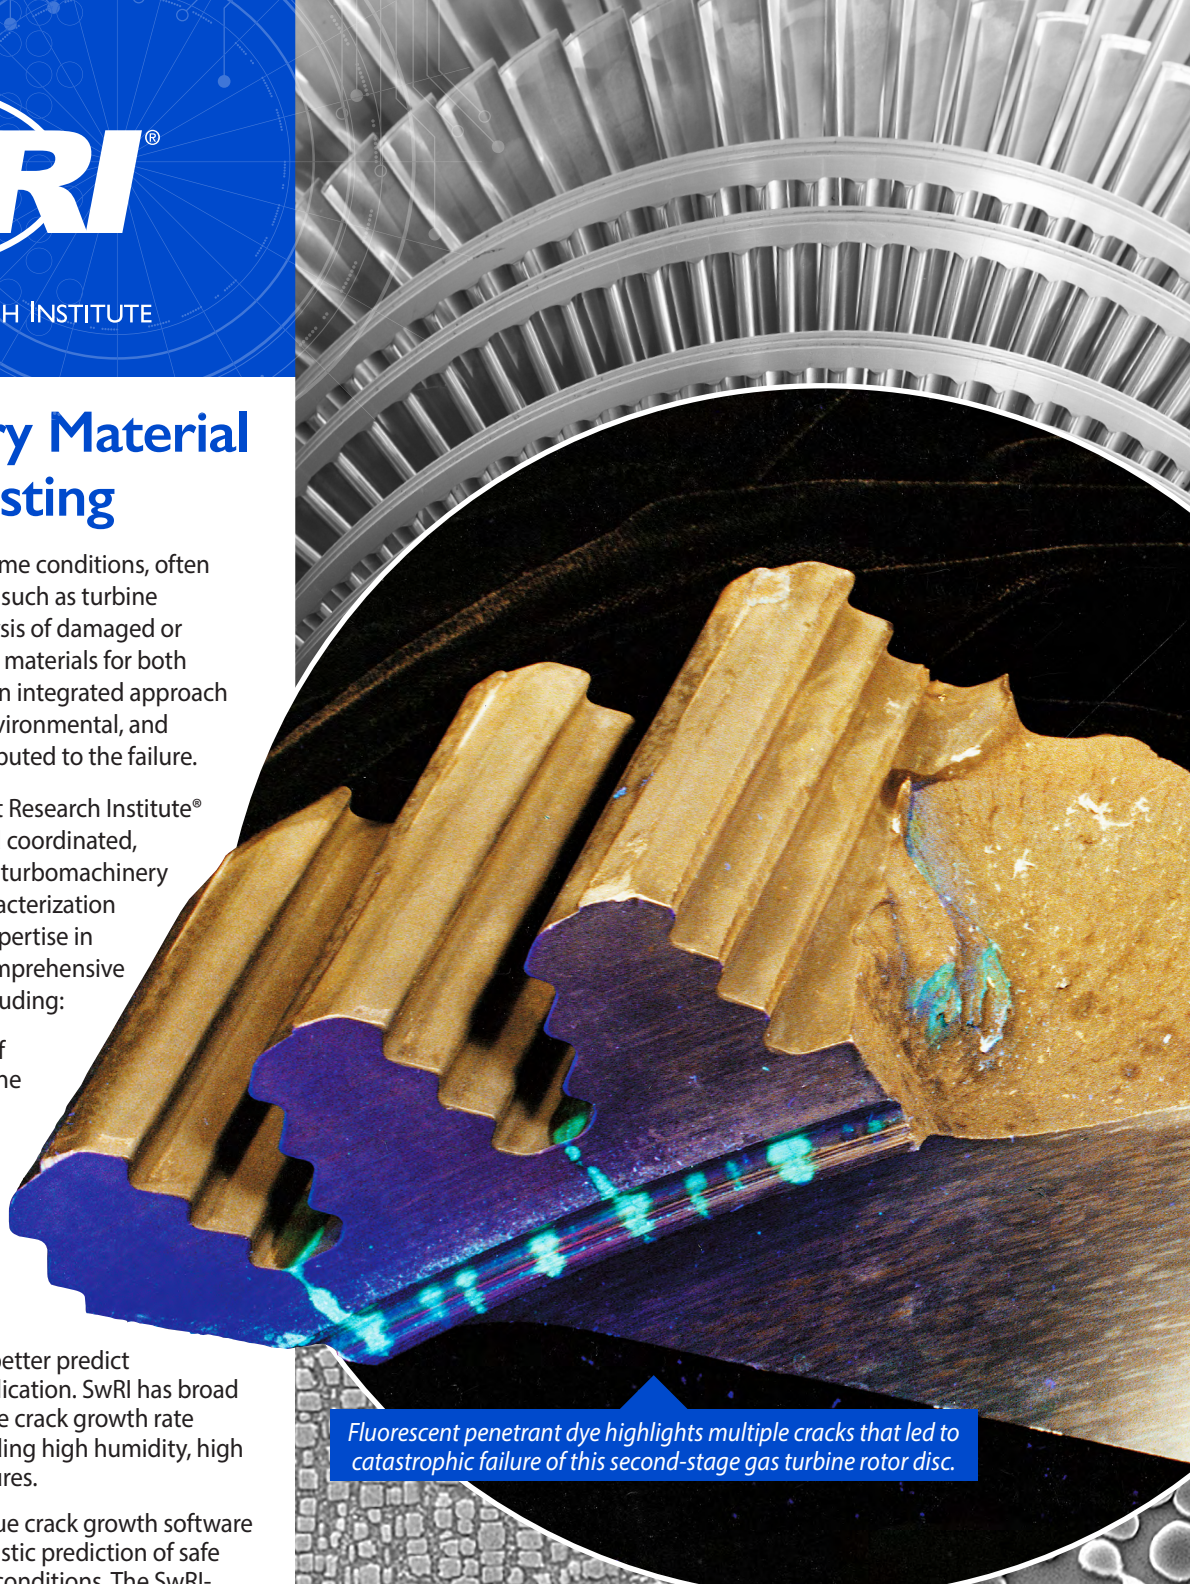
Fluorescent penetrant dye highlights multiple cracks that led to catastrophic failure of this second-stage gas turbine rotor disc.

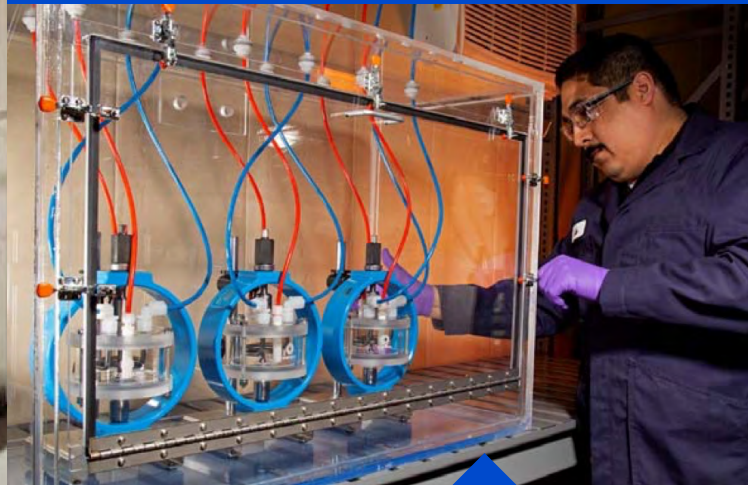
An SwRI technician prepares environmental test cells to simulate corrosion attack under service conditions.
